NISTIR 89-4066

# Environmental Evaluation of the Portland East Federal Office Building Preoccupancy and Early Occupancy Results

April 1989

Prepared for:  
U.S. General Services Administration  
Washington, DC

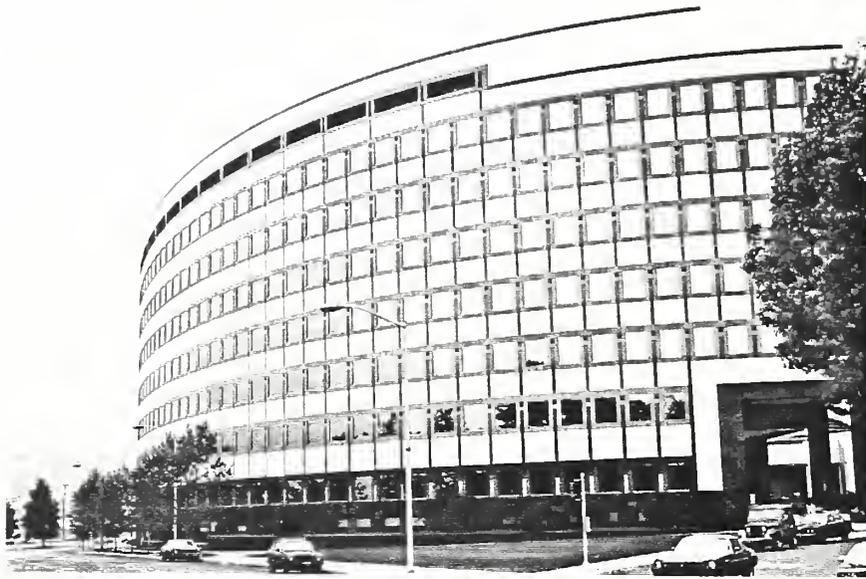
Figure 1. Exterior View of the New Federal Office Building

The new Federal office building is a seven-story office building with a one-story basement and a two and one-half story underground garage (see figures 1 to 7). Attached to the building on the first floor are a dining room and kitchen (figures 3 and 4). The penthouse of the building houses a mechanical equipment room which serves the first through seventh floors. There are three main HVAC systems which serve respectively the east, center and west cores of the building. These three systems have a total capacity of approximately 140 m<sup>3</sup>/s (about 3 air changes per hour). Each HVAC system has one return fan, two cold supply fans and a hot supply fan. These three HVAC systems are variable-air-volume systems (VAV). On the B1 level (occupied basement level-figure 5) there are four air handling systems which serve various sections of the basement. The B1 level also contains the loading dock. Above and to the north of the loading dock is an air handling system for the dining room. In the underground garages there are four exhaust fans which are activated when the carbon monoxide levels in the garage reach 50 ppm. The occupied area of the building is approximately 46,000 m<sup>2</sup> and the volume is 180,000 m<sup>3</sup>. The garage is connected to the occupied space by several stair and elevator shafts. The general interior plan of the building (figures 6,7) is that of an open architecture which each occupant having a space enclosed by 5 ft. partitions. On most floors there are enclosed offices for supervisors and enclosed conference rooms that do not have separate air handling systems. The second floor of the building contains a computer facility.

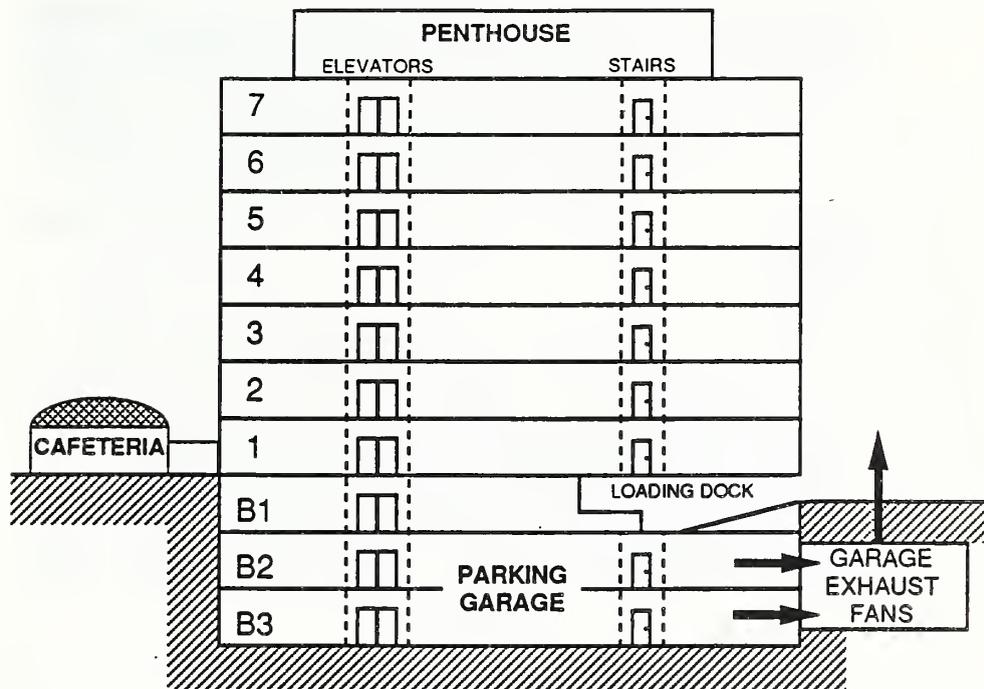
Figure 3. Schematic of the New Federal Office Building

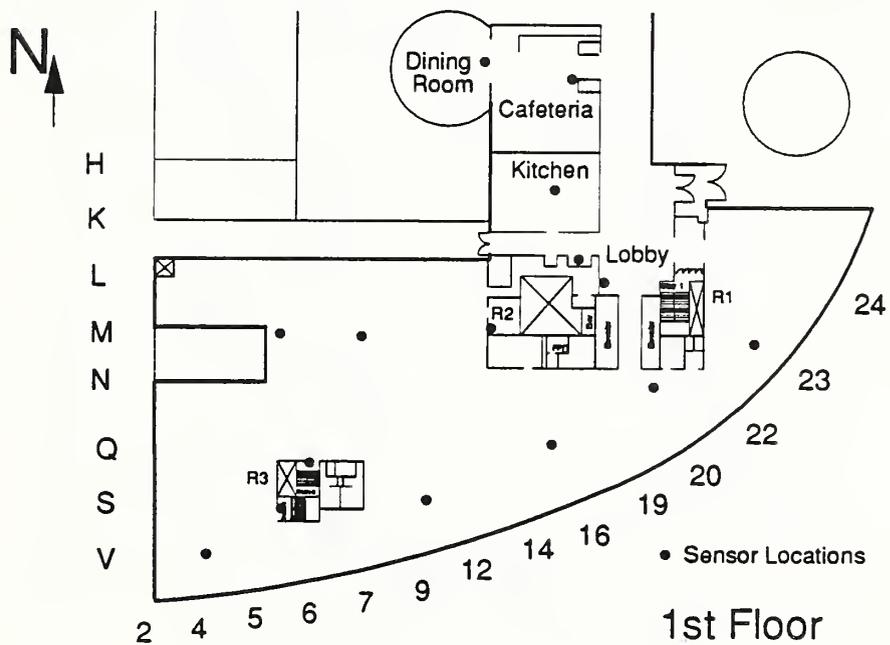
Figure 4. Schematic of First Floor

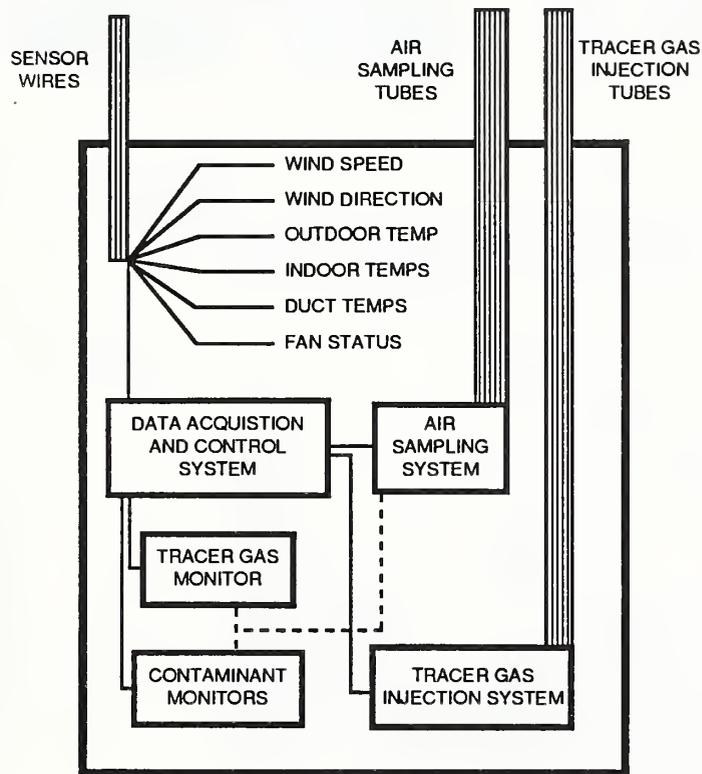
Figure 8. Schematic of Diagnostic Center

A diagnostic center was installed in the building during the later stages of construction. A schematic of this diagnostic center is shown in figure 8. The instrumentation [1] of the diagnostic center was designed to measure automatically the air infiltration and ventilation rates of the building, internal temperatures and humidity, exterior temperature, wind speed and direction, the indoor and outdoor levels of carbon dioxide and carbon monoxide and the indoor levels of respirable particles in six size ranges (0.3-0.5, 0.5-0.7, 0.7-1.0, 1-5, 5-10 and >10 microns). Figure 9 shows a view of the instrumentation systems installed in the diagnostic center. In addition, measurements were made of the concentrations of formaldehyde, radon and volatile organic compounds.

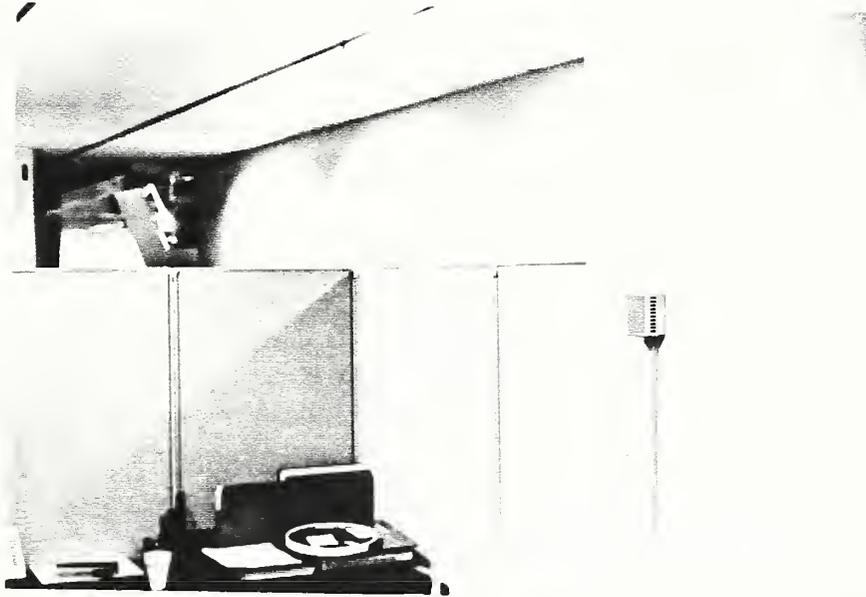
Figure 10. Space Air Sampling Location

The sampling stations in the building were located in both the interior space and in the air handling systems. In general each air handling system had three air sampling locations: one down-stream of the supply fan, one up-stream of the supply fan and one in the return fan. These sampling points were connected directly to the diagnostic center through 3/8 inch OD nylon or polyethylene tubing. Each air handling system had two injection points for injecting tracer gas (one up-stream and one down-stream of the supply air fans). These points were connected to injection manifolds with 1/8 inch nylon tubing. On each floor there were between 8 to 12 interior space sampling locations at a height of approximately 5 ft. above the floor (figures 10,11). In addition there were sampling points in the exhaust of each air handling system. Typical locations of the sampling points within the occupied space can be seen in figures 4 - 6. These floor sampling locations were connected to floor panel boxes by either nylon or polyethylene 3/8 inch tubing when run under the raised floor, or 3/8 copper tubing (a fire requirement) when run through the ceiling return air plenum. Each floor panel had six 3/8 inch polyethylene tubes which ran to the diagnostic center on the B1 level. These six tubes were connected to the desired floor sample locations. This permitted easy changing of sampling locations, and through the use of tees and jumpers, the creation of a large variety of average sampling strategies. (One particularly useful strategy was to tee together one central

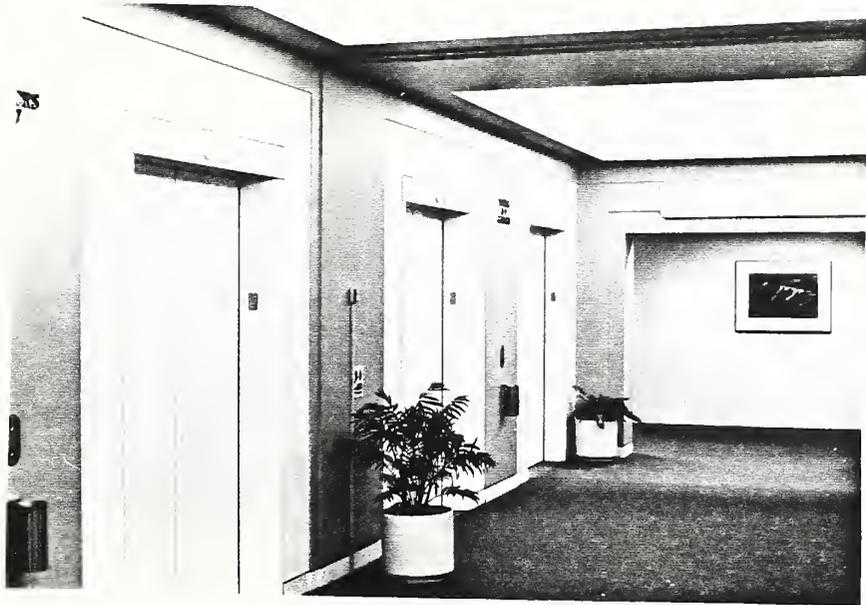
Figure 11. Elevator Lobby Air Sampling Location

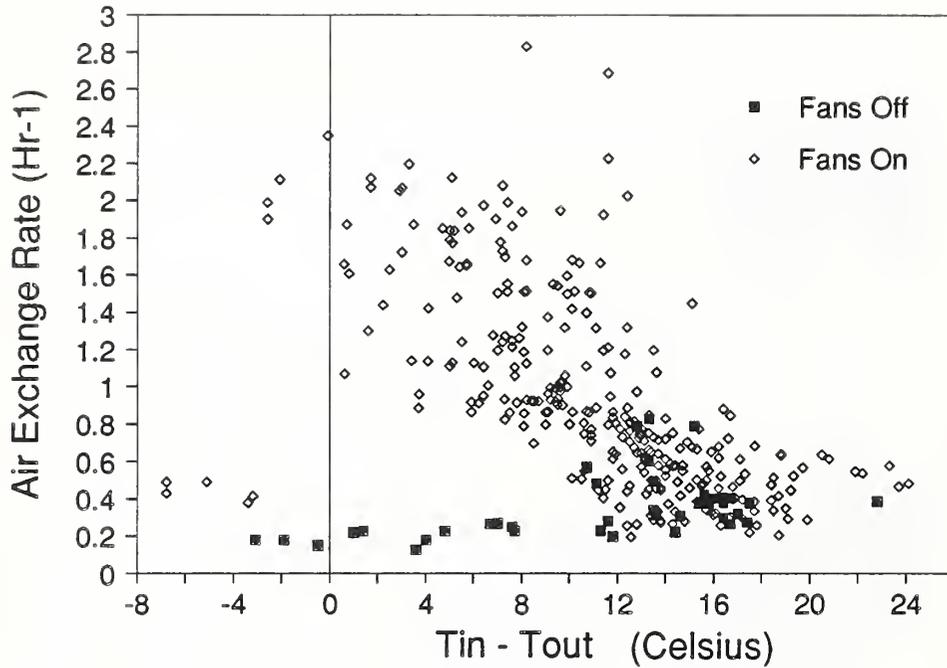
Figure 12. Air Exchange Rate versus Inside-Outside Temperature Difference

The building ventilation and air infiltration rates are shown in figure 12 as a function of inside-outside temperature difference. Building ventilation rates (open diamonds) are between 0.4 to 2.2 air changes per hour during periods when the building is occupied. The minimum value of 0.4 occurs during extremely hot summer conditions or extremely cold (for Portland, OR) winter conditions. For comparison, the new ASHRAE ventilation standard requires 20 cfm per person for office buildings. This is equivalent to about 0.7 air changes per hour if the building is occupied at a density of one person per 135 ft.<sup>2</sup>.

The building air leakage (uncontrolled air exchange when the HVAC fans are off during unoccupied hours - solid squares) is between 0.2 and 0.4 air changes per hour. This is a building designed to be energy efficient and these values indicate that the exterior walls of the building are not tight but can be considered typical of US office buildings. (Note: The surface

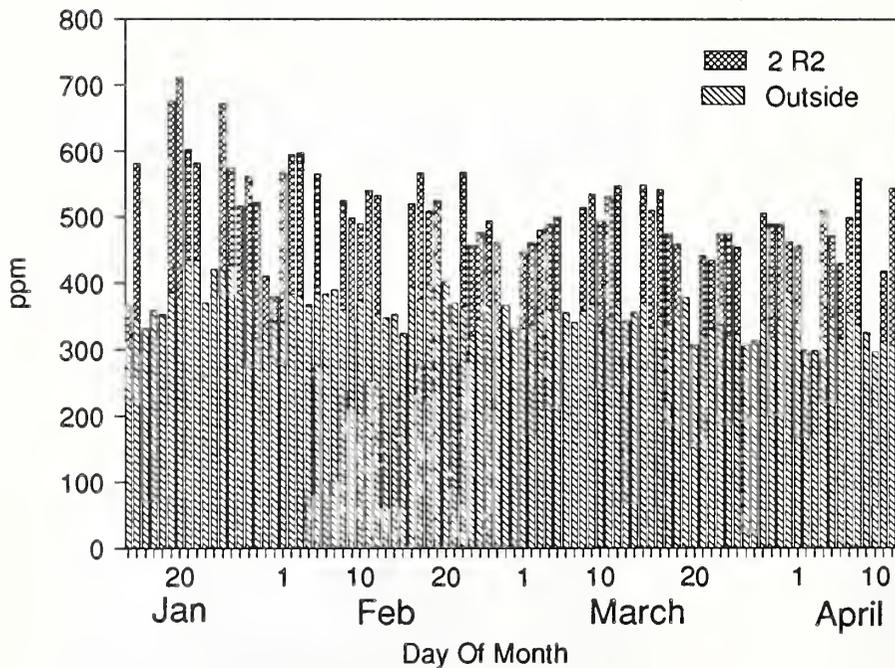
Figure 13. Daily Maximum Carbon Dioxide Levels for Months of January through April 1988

The daily maximum carbon dioxide levels for the months of January through April are shown in figure 14. Figure 15 shown the maximum daily CO<sub>2</sub> level as a function of air exchange rate. Carbon dioxide levels are seldom over 600 ppm on a building average and only a couple of times ever over 1000 ppm at any location in the building. (The new ASHRAE standard proposes a maximum level of 1000 ppm, complaints from building occupants begin to occur when levels exceeded 600 ppm). A closer examination of the hourly CO<sub>2</sub> levels in the building shows that the levels are never at steady state and usually have two daily peaks - one around 11 am and the other around 3 pm. The fact that steady state is not obtained is also shown by the values of the constants of the fitted curve in figure 14. The value of 100 is approximately 1/3 the expected equilibrium value based on the occupancy of the building.

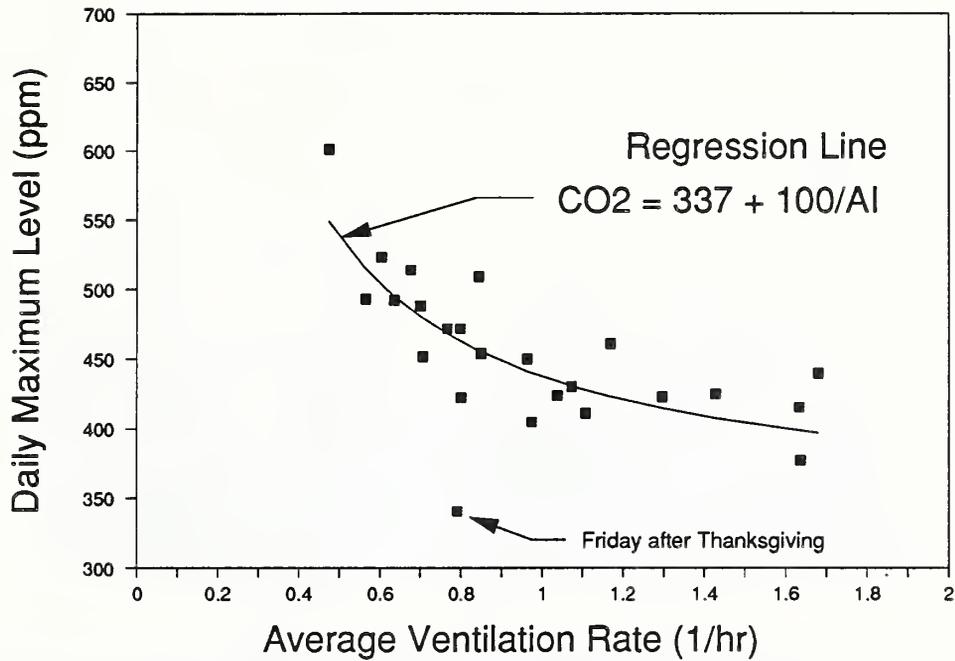
Figure 14. Carbon Dioxide Level versus Ventilation

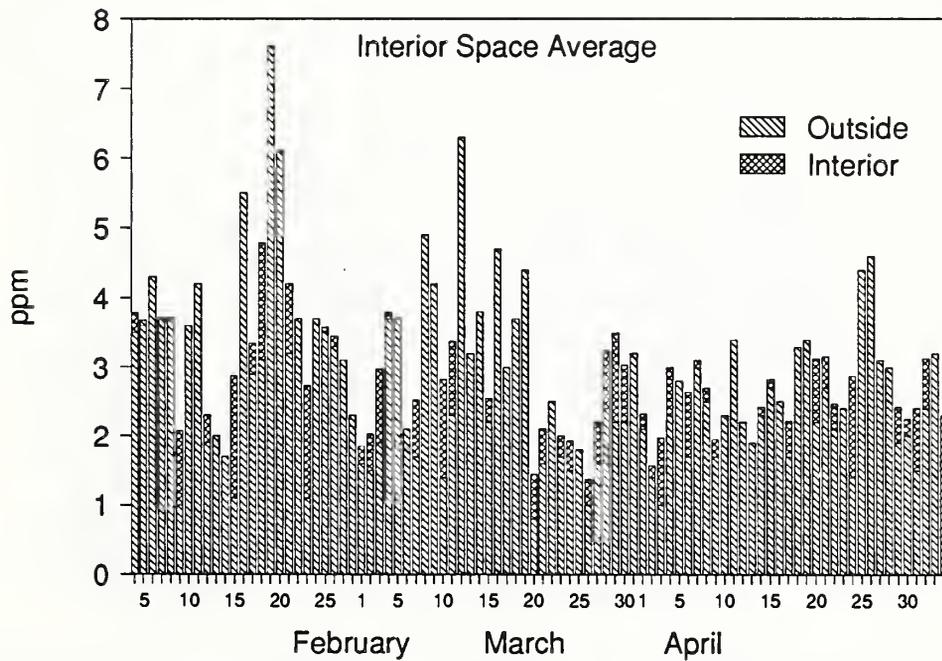
Figure 15. Daily Maximum Carbon Monoxide Level in Interior Office Space for Months of February to May

The levels of carbon monoxide in various parts of the building are shown in figures 15 through 20. Figure 15 gives the daily maximum carbon monoxide levels in the interior space for the months of February to May. Figure 16 shows the high levels of CO occurring in the elevator lobby on the sixth floor. Figure 17 shows the daily peaks of CO on the B2 garage level. Figure 18 gives the peak reading of CO in the elevator lobby on the B1 level. Figure 19 shows similar maxima for the B1 level loading dock. An examination of the data in these figures and the more detailed hourly data shows that during the fall and early winter months, there were occasional incidents of excessive carbon monoxide levels (greater than 10 ppm) in the upper building (figure 16) due to the flow of air from the underground parking garage toward the elevator shafts and stairwells. (Note the ASHRAE required level is 10 ppm and complaints may begin to occur at 5 pp, the National Ambient Air Quality Standard (NAAQS) is 35 ppm for 1 hour and 9ppm for 8 hours.) It seems that the automated sensors in the garage do function as designed, (activating the garage's exhaust fans when the level in the garage exceeds 50 ppm (see figure 17)). However, this intermittent operation is not sufficient to prevent the transport of CO up the elevator shafts (figure 16) and stairwells in extreme weather conditions when the stack effort is strongest. Once the garage exhaust fans (at least two of the four) were operated continuously during occupied hours, the CO level in the office space never exceeded 5 ppm.

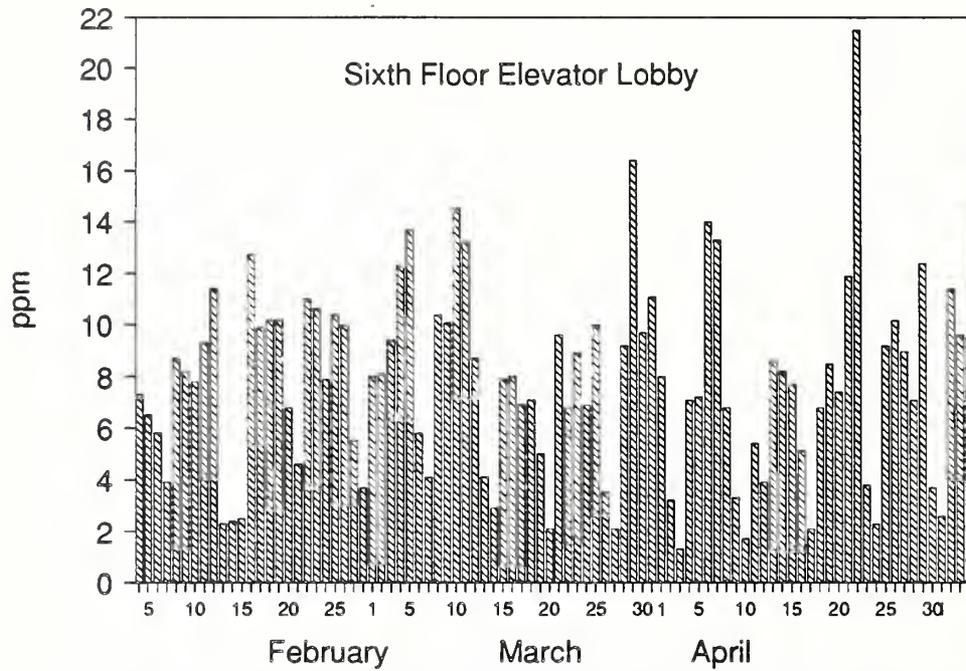
Figure 16. Daily Maximum Carbon Monoxide Level in Sixth Floor Lobby for Months of February to May

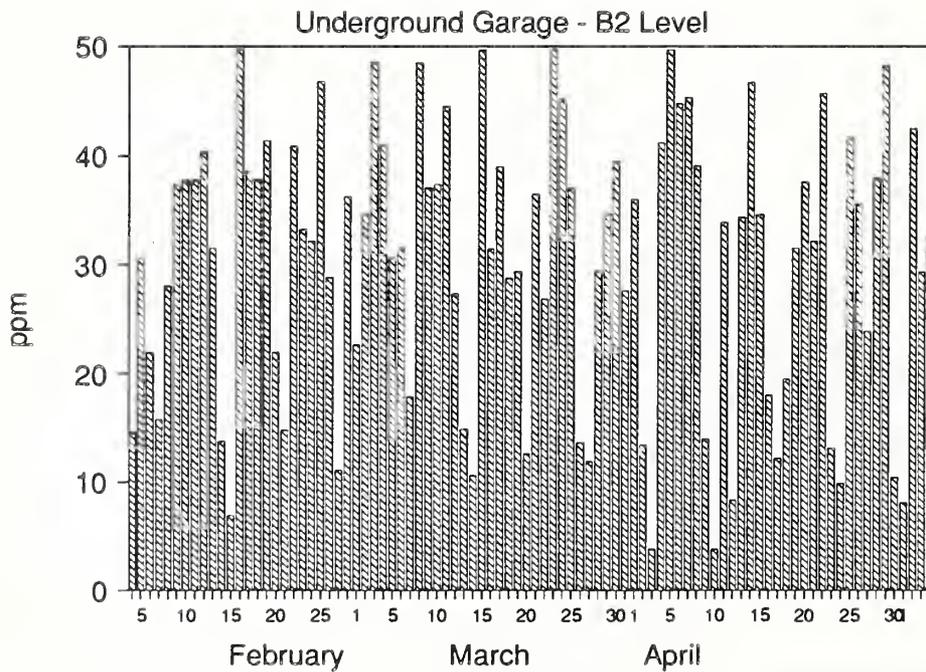
Figure 17. Daily Maximum Carbon Monoxide on B2 Level for Months of February to May

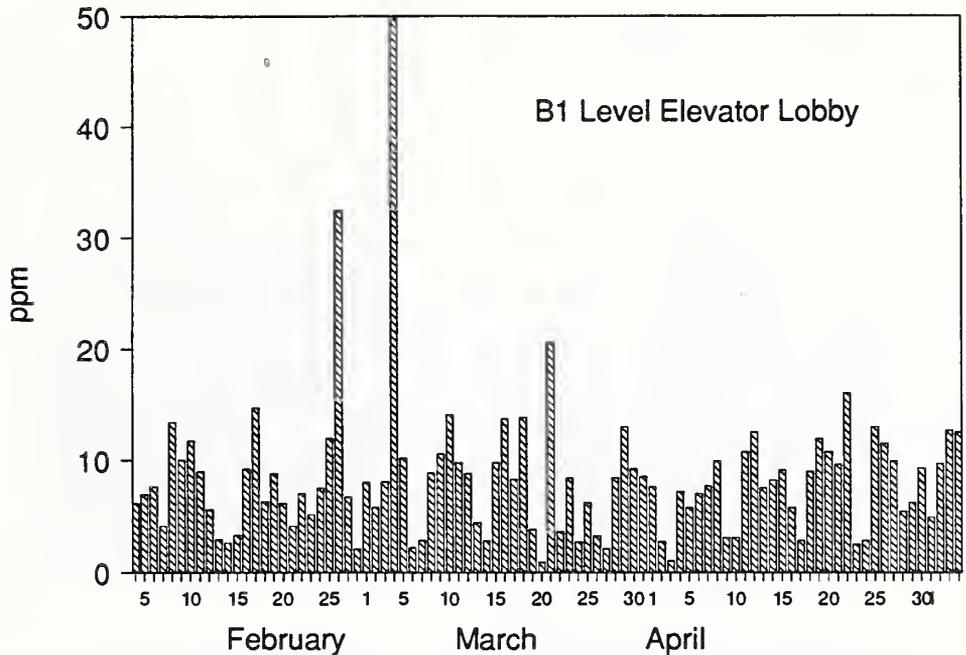
Figure 18. Daily Maximum Carbon Monoxide Level on B1 Level for Months of February to May

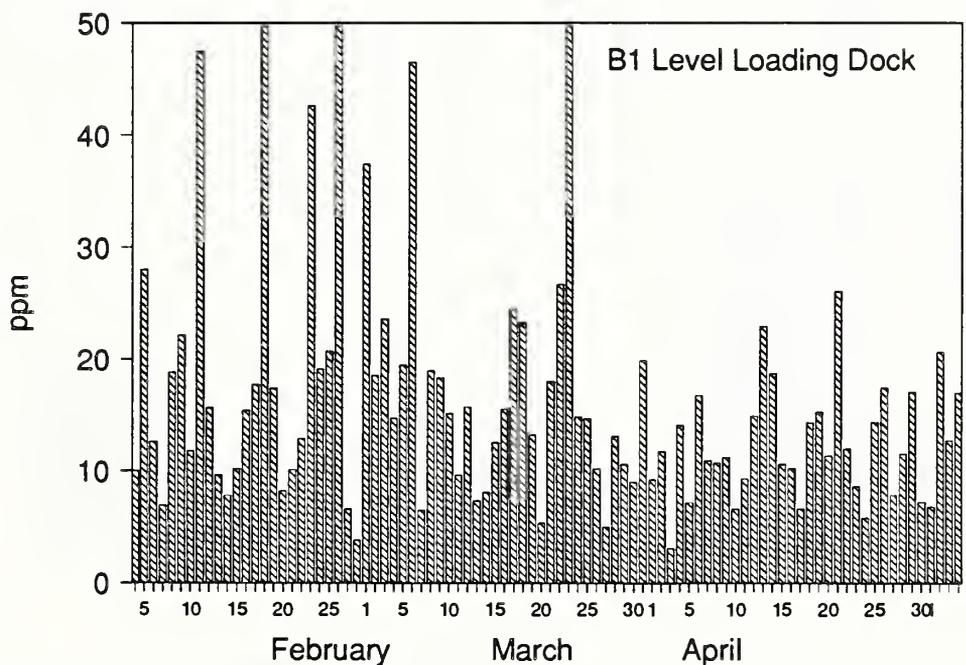
Figure 19. Daily Maximum Carbon Monoxide Level on Loading Dock for Months of February to May

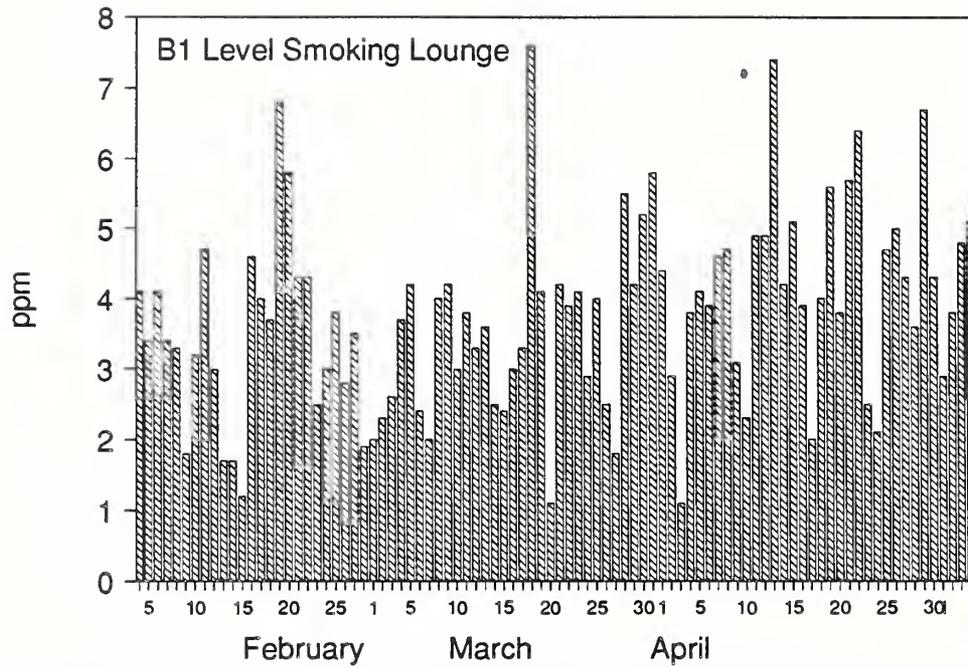
Figure 20. Daily Maximum Carbon Monoxide Level in Smoking Lounge B1 Level for Months of February to May

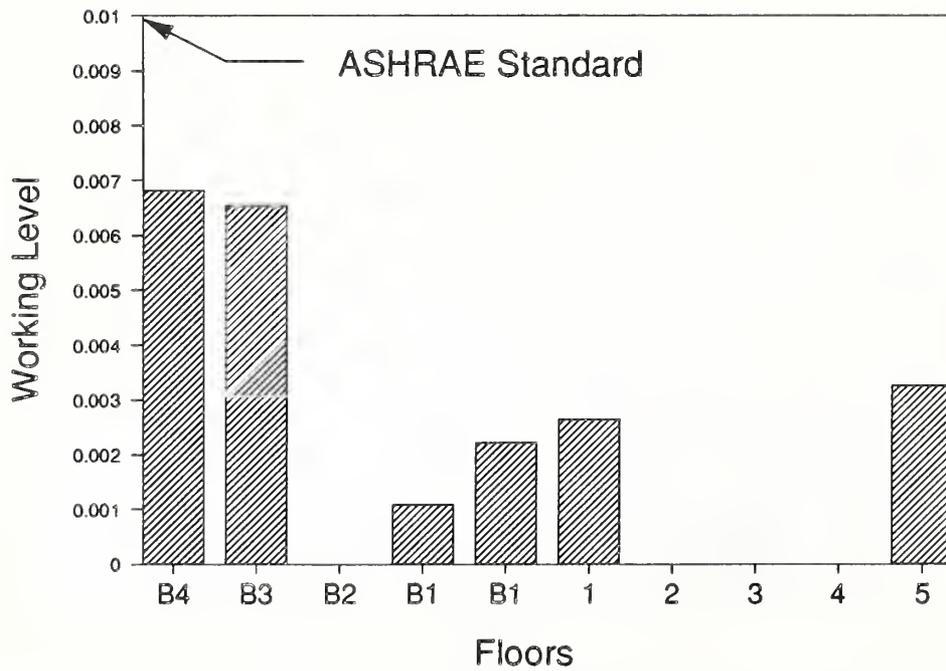
Figure 21. Working Levels of Radon Daughters

Figures 21 and 22 shows the results of the radon testing in the building. The measured radon levels in the building are below 0.007 working levels (the ASHRAE level is 0.01 working levels, the EPA action level is 0.02 working levels) as measured in terms of the equivalent radiation impact of the radon daughters, and are less than 1.2 pCi/l (the ASHRAE recommended level is 2 pCi/l, the EPA action level is 4 pCi/l) in terms of the amount of radon gas. The radon levels in the low garage levels are higher than those those of the upper floors. It is interesting to note that the upper floors of the occupied space are consistently higher in radon level than the lower above ground levels. This can be attributed to the fact the air flows into the elevator shafts and stairwells on the lower levels and out of these shafts on the upper levels.

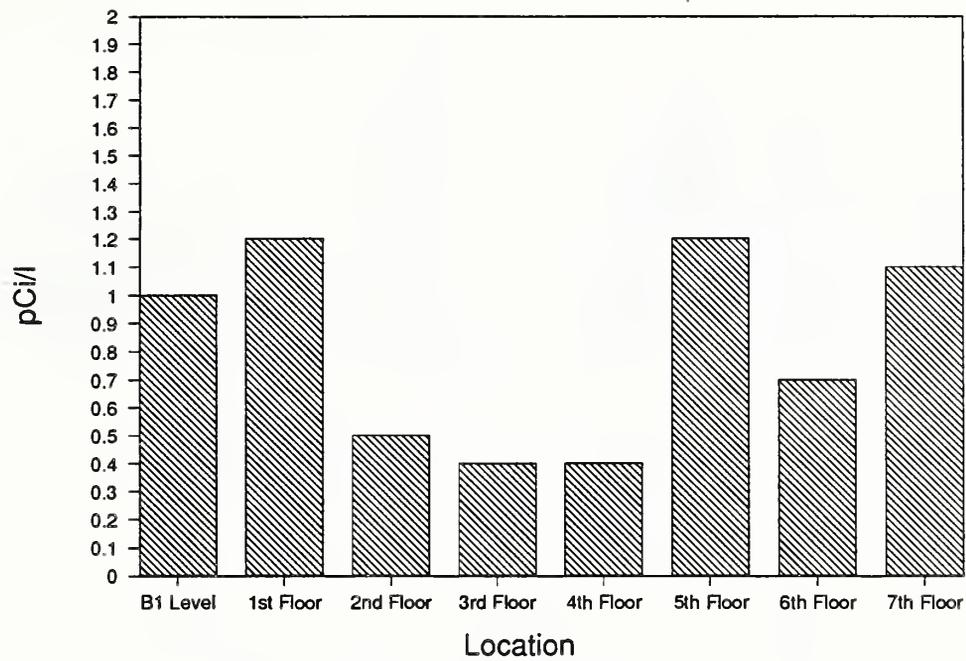
Figure 22. Radon Levels as Measured with Charcoal Canisters

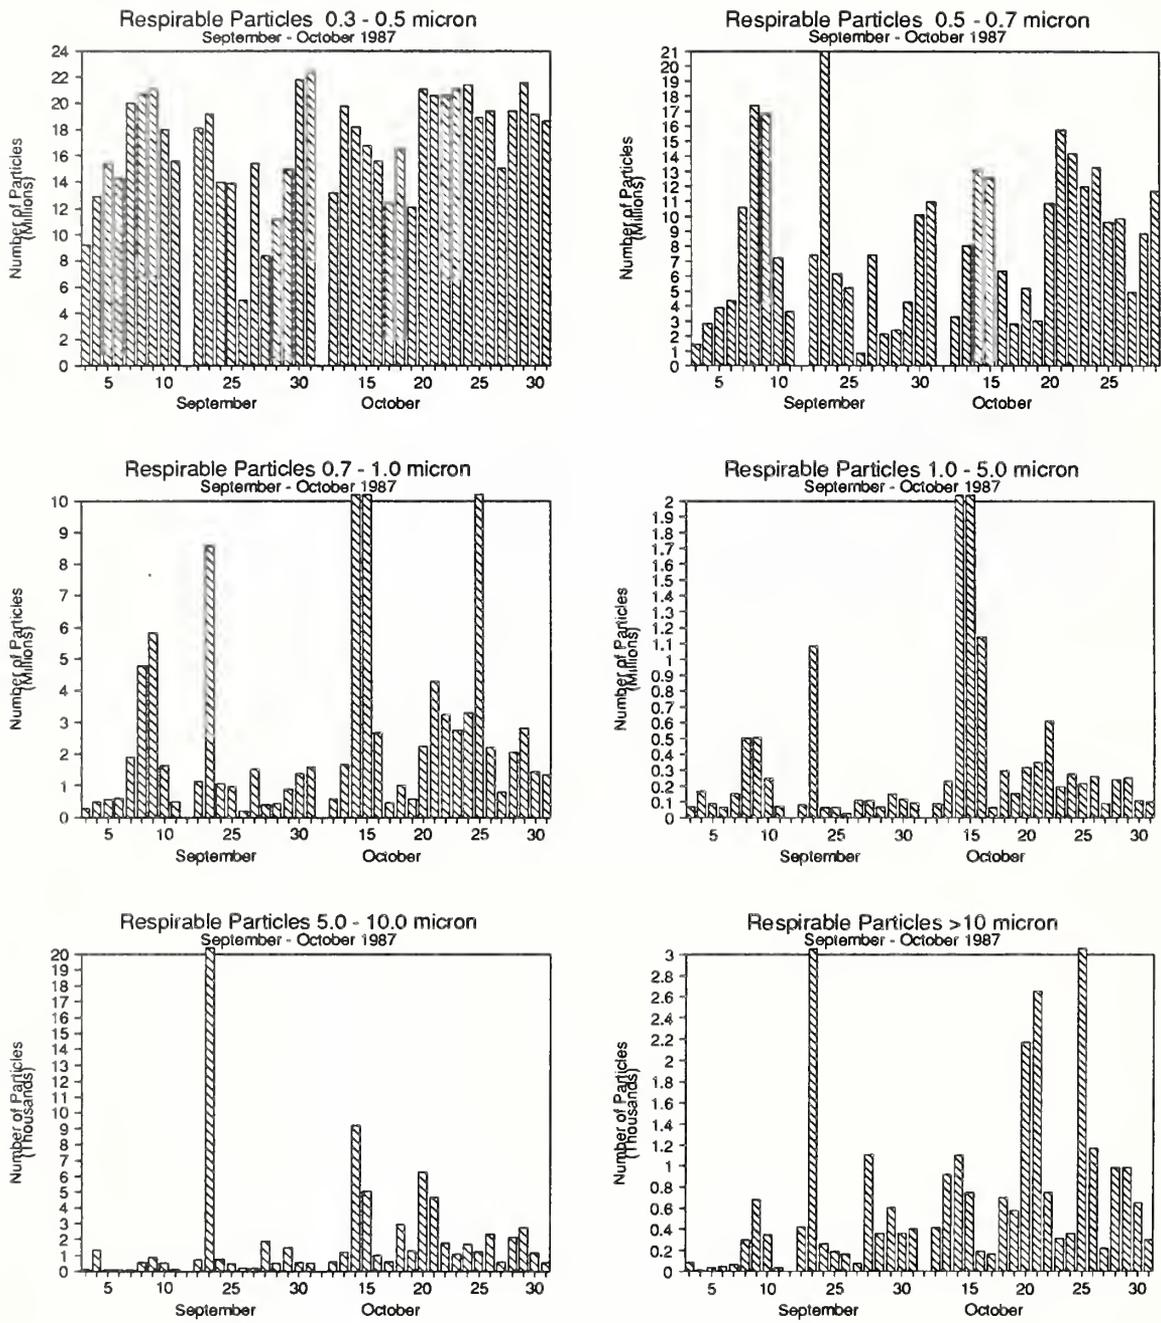
Figure 23. Respirable Particles in Various Size Ranges for Months of September and October 1987

Figure 23 shows the maximum daily concentrations of respirable particles in the six size ranges of 0.3-0.5, 0.5-0.7, 0.7-1.0, 1-5, 5-10 and greater than 10 microns. The levels of the fine particles in the 0.3 to 0.5 remain fairly constant and show little hourly or daily variation. The three size range of 0.5-0.7, 0.7-1.0 and 1.0 -5.0 have much more pronounced variations. The two size ranges greater than 5 microns are not considered respirable. The high levels of particles in the ranges 0.7-1.0 and 1.0-5.0 micron for the period around October 15 were caused by the sweeping of the parking garage with street-type sweeping machines. The building maintenance staff reported that all filters in the air handlers had to be replaced after the sweeping of the garages. In general the levels of respirable particle levels in the building (particles of a size less than 3 microns) are in the 10 to 15 million particles per cubic meter range, typical for office buildings without smoking which we have measured (data from a limited number of buildings). It is difficult to compare the measured particle levels with established standards since the standards are given in micrograms per cubic meter and there is great uncertainty in converting from particle counts per cubic meter to micrograms per cubic meter without more detailed analysis of the composition of the particles present in the building.

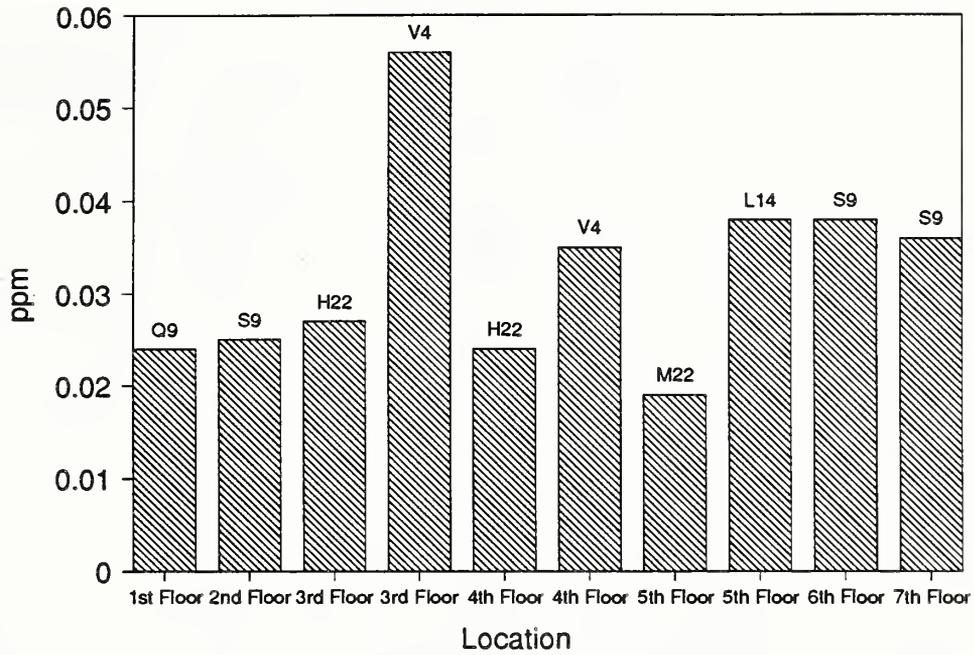
Figure 24. Formaldehyde Levels in Building

The level of formaldehyde in the building was measured in August 1986 during the period when the new furniture was being installed and the occupants were moving into the building. The carpeting (removable carpet squares with a pressure sensitive adhesive) was installed during the months of April through July in most parts of the building. The results of these measurements are shown in figure 24. The measured formaldehyde levels are less than 0.056 ppm (the ASHRAE level is 0.1 ppm, complaints begin at 0.06 ppm, outside levels are typically 0.04 ppm). There is no significant outgassing of formaldehyde from the building's furnishing and carpets.

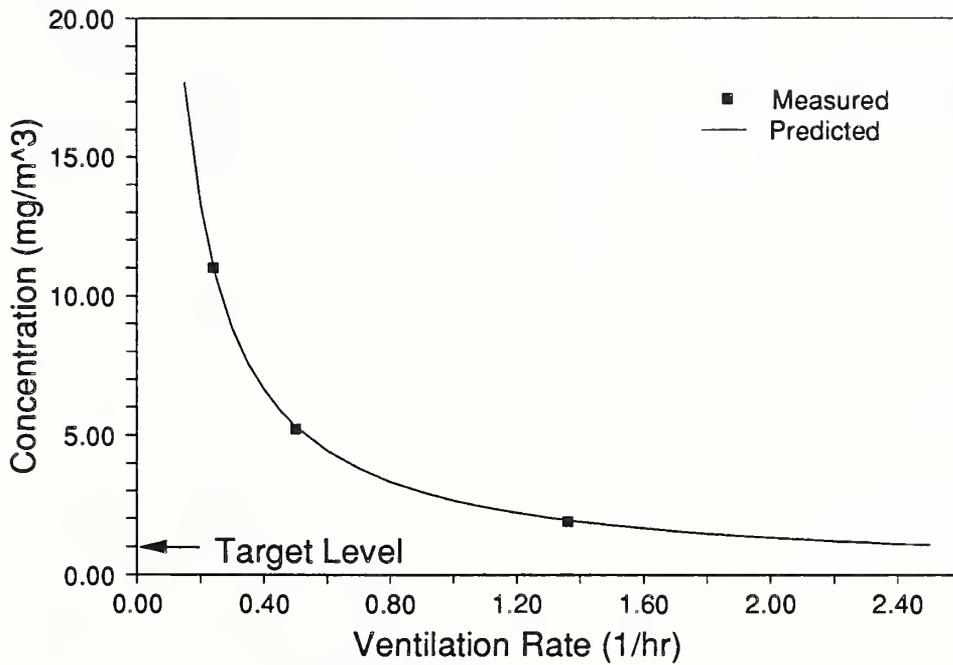
Figure 25. Total Volatile Organics versus Ventilation Rate

The last class of pollutants measured was the volatile organics. The results are given in Table 1. The measurements were made on three different occasions: August 4, 1987 when the occupants were moving into the building, October 14, 1987 and January 13, 1988. On each of these dates the building was being operated with three distinct air exchange rates (0.5, 1.36 and 0.24 changes per hour) due to the prevailing exterior weather conditions. Figure 25 shows the effect of building ventilation rate on the total VOC concentration. The curve in figure 25 represents the predicted level in the building using the source strengths in table 1. The source strength of total VOC is remarkably constant over the five month period between the first and last measurements. We have measured and identified 37 volatile organic compounds in the interior building space. There are 5 oxygenated compounds, 6 halogenated compounds, 16 alkanes, 6 cycloalkanes and alkenes, and 5 aromatic hydrocarbons. All are at levels less than 1/1000 th of the OSHA standard environmental levels of industrial work spaces. (Note: The

ASHRAE standard recommends that for indoor air quality the level be not more than 1/10 of OSHA SEL's.) The largest amount of the mass of the VOC's is concentrated in the alkane class ( $C_{10}$  to  $C_{12}$  branched decanes and undecanes). These are not particularly irritating compounds and there are no OSHA recommended levels for these substances. However very limited studies done in Denmark by Dr. Molhave [3] indicated that many complaints will occur when the total levels of VOC's exceeds  $5 \text{ mg/m}^3$  and it has been recommended by researchers [4] at EPA Research Triangle Park that a prudent target level for total VOC's be  $1 \text{ mg/m}^3$ . All three measurements sets that were made in the building were greater than  $1 \text{ mg/m}^3$  and the building exceeded  $5 \text{ mg/m}^3$  when the ventilation rate was below 0.5 air changes per hour. The sources of these compounds have not yet been identified; however we have tested the major building components and furnishings for outgassing and these are not the sources. We suspect that they are activity related and we are making an effort at identifying these activities. Though operating the ventilation system always at 100 percent outside air would keep the levels near the target of  $1 \text{ mg/m}^3$ , identification and limitation of the sources is generally a better strategy.
